**CONTRIBUTION FOR CIGRE SC12/A2- MERIDA- KOLLOQUIUM
June 2 - 4, 2003**

**TRANSFORMER LIFE MANAGEMENT
GERMAN EXPERIENCE with CONDITION ASSESSMENT**

I. Höhle, A. J. Kachler*,
Siemens AG, PTD T, Nuremberg, DE

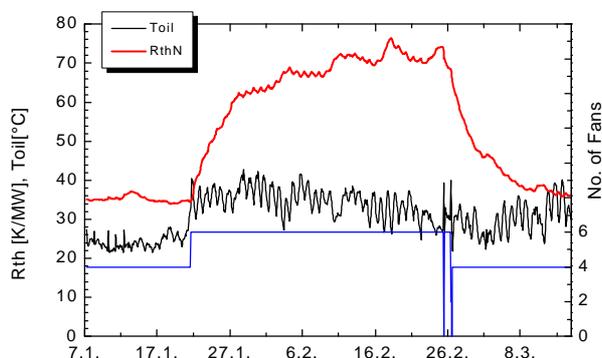
Fault Symptom: Increase of thermal resistance
Detected by: Online Monitoring (M)

On-line monitoring of the cooling unit of a 420kV / 600MVA grid-coupling transformer by calculation of the nominal thermal resistance R_{th} as described in [11,12] showed a strong increase after switching on of two additional fans which was signalled by the control system. This increase triggered a warning message by the monitoring system. A local check in the substation revealed that due to a failure of energy supply only half of the cooling unit (3 fans) was in operation and therefore only three fans were running. This status was not in accordance with the information of the control system and led to the strong increase of nominal thermal resistance. With the present load and half of the cooling power the transformer could be kept in service. But it would not be possible to operate the transformer with nominal load due to the missing cooling power. This scenario shows the importance of detecting also minor failures to avoid the risk of not delivering energy.

Fig. 1: Abnormal condition of cooling unit detected by increase of thermal resistance R_{th}

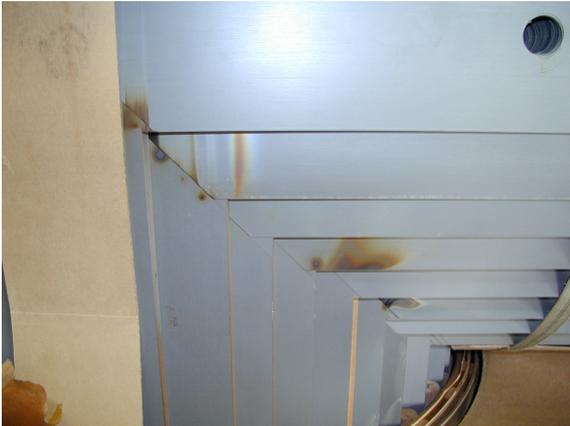
The rectifier was returned to the factory for repair. A core burn (See Fig. 2) as a consequence of a transport damage was the source of the abnormal circulating currents in the core. The core has been repaired.

Diagnosis: Core burn as a consequence of high circulating currents.

Fig 2: A severe core burn as a consequence of high circulating currents

Action taken: repair of the core and introduction of magnetic shielding.

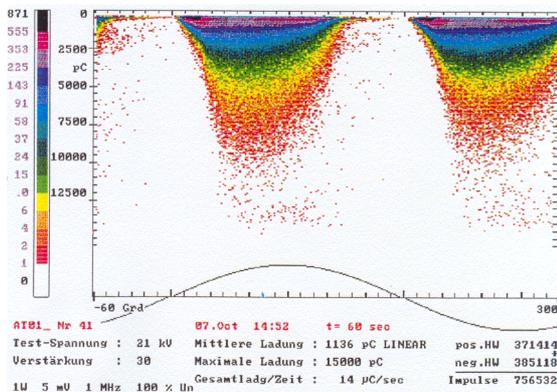
To clarify this, a RVM and a frequency-dependent impedance measurement were performed but without any defect indications. Then on-site partial discharge measurements were made by a PRPDA (Phase Resolving Partial Discharge Analyser). Two partial discharge sources of the same kind were clearly indentified at phase V and phase W (Table 5, Fig. 3).

Fig 3: Example of PD Activity at Phase W (HV)

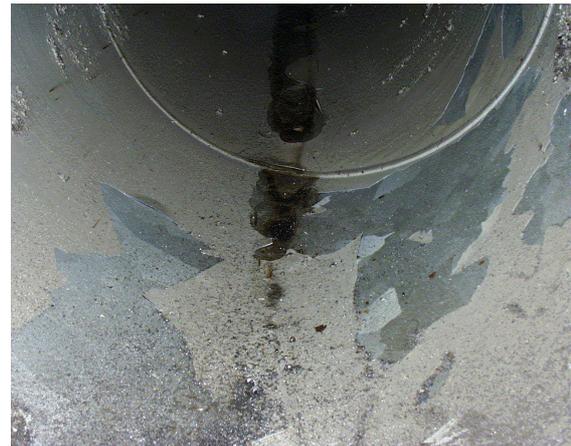
Because of these the transformer was returned to the manufacturer for dismantling. The dismantling revealed a strong decontamination with particles and many discharge points especially at the upper end insulation of the hv-winding.

The discharges were caused by the particles from the inner coating of the tubing (Fig. 4) of temporary connected cooling plant.

Fig 4: Paint particles from the cooling plant, causing PD

Diagnosis: Severe contamination of all windings from the piping of a cooling plant, with severe PD tracking.

Action taken: Repair. New windings and cleaning of the cooling plant.

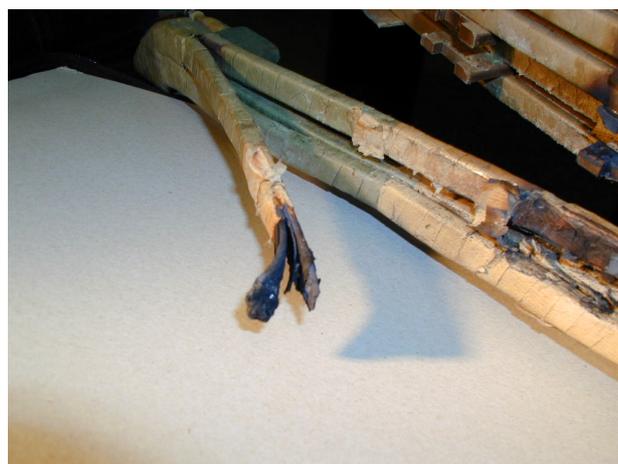
One broken twin conductor of two twins with burnt out insulation paper was detected. The damage location was a defective solder joint. The damage location has been a localized thermal source, because the DP-value of neighbouring insulation paper was not affected.

Fig 5: A broken twin conductor as a consequence of a defective solder joint

Diagnosis: Defective solder joint

Action taken: The winding was repaired and the transformer was taken in service again and is working troublefree.

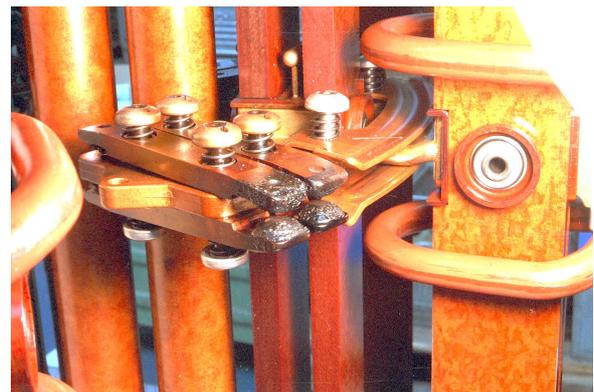
any current dependency. However, unusually high and unstable contact resistances were determined at the change-over selector. For this case a special surface resistance measurement was developed. Even after an increased number of change-over selector operations, the resistance values did not show any improvement. This behaviour indicated quite a heavy coke layer on the contacts, which could not be removed by simple switching. The transformer was opened, the selector was inspected and the change-over contacts were exchanged. The change-over contacts were covered with a thick carbonized layer with a significant surface erosion – see Picture. Such contact damage mainly appears on change-over selectors made of copper (movable contact) and brass (fixed contact) which are rarely operated. Caused by the slight tarnish, the contact resistance increases, and, consequently, the temperature of the contacts, too. The increased contact temperature accelerates the growth of tarnish and the temperature is high enough to decompose the oil and oil carbon is generated (Fig 6). In the course of time heavy layers (oil carbon) will be built up.

Fig 6: Eroded contacts of the tap selector with a coke layer.

Diagnosis: Oil-carbon layer on the copper and brass selector-over contacts.

Actions taken: Exchange of the contacts, on-site repair with consequent oil degassing.

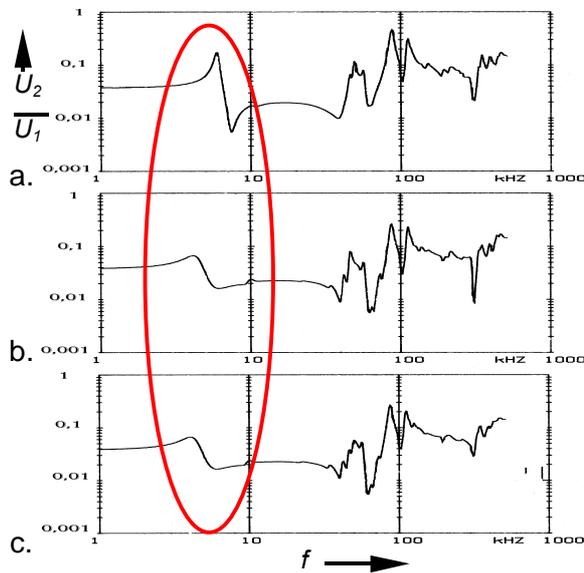
was analyzed in the frequency domain (Fig. 7) and it clearly showed a significant deviation for phase U against Phase V and W. This clearly coincides with the defect found during disassembly.

Diagnosis: DGA, interdisc short circuit at 2nd/3rd disc at the ground side of HV winding with a secondary effect of an axial flashover due to excess gas generation.

Fig 7: Transfer Function Analysis of a 175 MVA/520 kV GSU Transformer

Actions taken: Due to the heavy contamination of carbon the complete set of phase windings on phase U/LV/HV regulating winding was replaced.

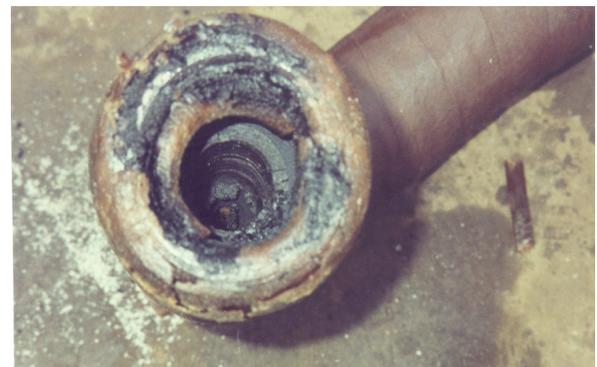
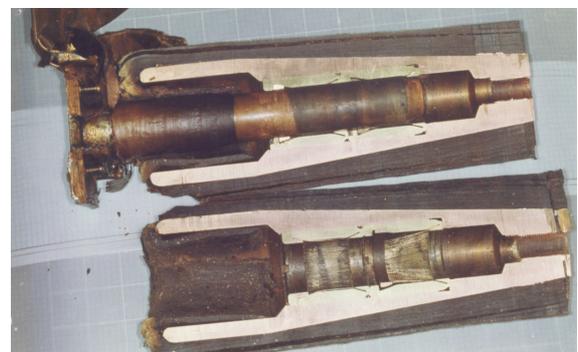
The DP values of the insulation at the connectors was between 150-250, i. e. It has reached its end of life (Fig 8a and b). The DP values on the low voltage lead was 500 -600. Since this is a GSU of a nuclear power plant no further risks were taken and the unit was replaced by a new transformer in 1993.

Fig. 8a, b : Connectors with fully burnt out solid insulation

Diagnosis: Overheating of the connectors because of stray currents and consequent degradation of the cellulose insulation.

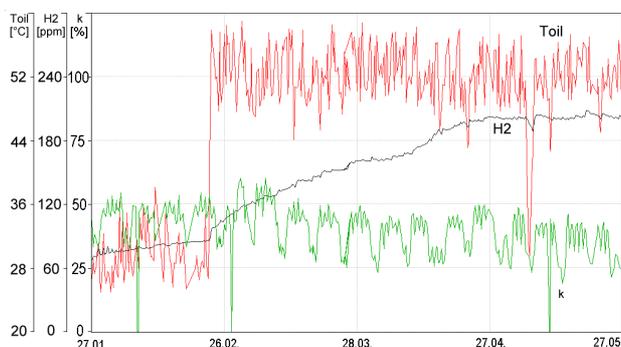
A 400kV/300MVA grid coupling transformer was put into operation after repair with a new active part and installation of an on-line monitoring system. After commissioning the content of hydrogen detected by the on-line monitoring system increased continuously (Fig. 9). An increase of oil temperature by special control of the cooling unit revealed that the concentration of hydrogen is only dependent on the oil temperature. A correlation with the load factor k could not be detected. Therefore, an abnormal condition like partial discharges or hot

spots due to load current could not be possible. The reason for the generation of hydrogen is due to chemical reactions of the new transformer oil [10]. This behaviour during a transformer's initial operating period has become apparent as on-line monitoring has become common, and it has probably always occurred. Gas formation is most apparent in highly refined oils, probably because the hydrogen and hydrocarbon radicals there cannot react with any unstable structures, since there are no such structures. Also zinc in the pipes of the cooling unit can cause such an increase of hydrogen. An off-line dissolved gas analysis (DGA) to determine the concentration of the other components dissolved in the oil indicated no further gases than hydrogen. So evaluation of several variables by the monitoring system revealed that the generation of hydrogen is caused by chemical reactions and therefore in this case uncritical.

Fig. 9 : Hydrogen content dependent on top oil temperature
